Report on Archaeological Testing and a Preliminary Architectural Heritage Survey at Rathgowan, Mullingar, Co. Westmeath

Licence Numbers: 21E0518 and 21R0203
Report Author: Zbigniew Malek

June 2022

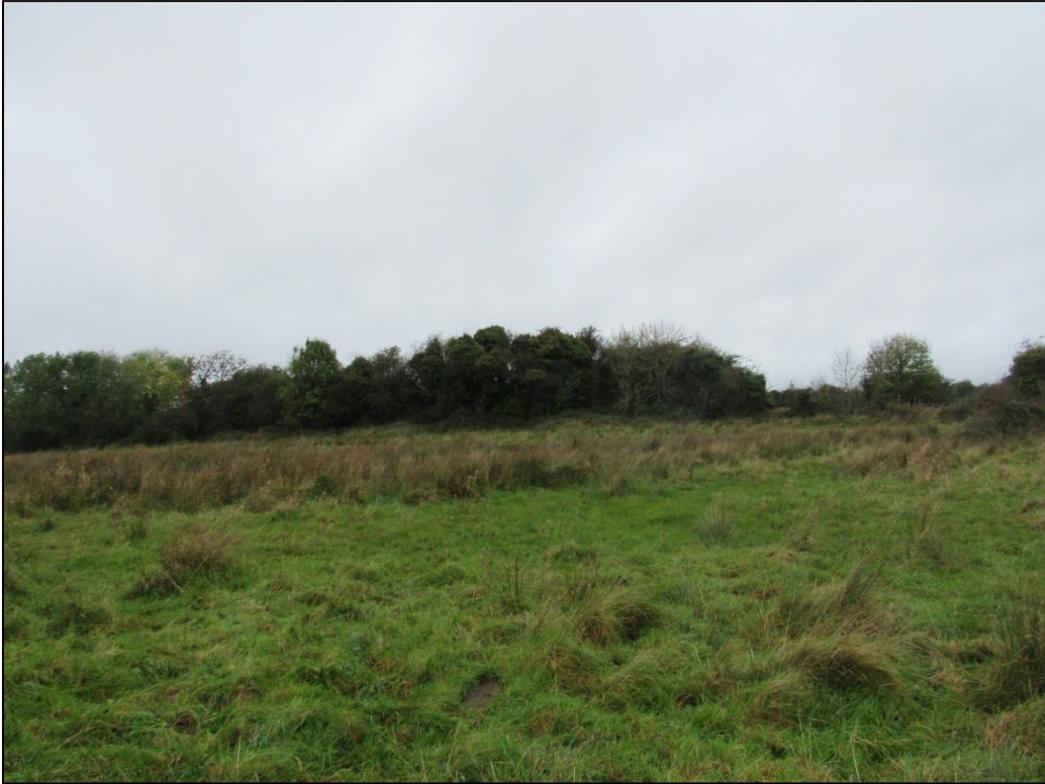
Plate 1: Area A, overview of the ringfort (WM019-046) and Zone of Notification, looking northwest.

It is recommended that no building works, drainage features or landscaping works are undertaken within an exclusion zone defined by the Zone of Notification (ZoN) for ringfort WM019-046 and that this buffer zone should be permanently fenced-off prior to groundworks commencing and defined by a line of trees within the finished development.

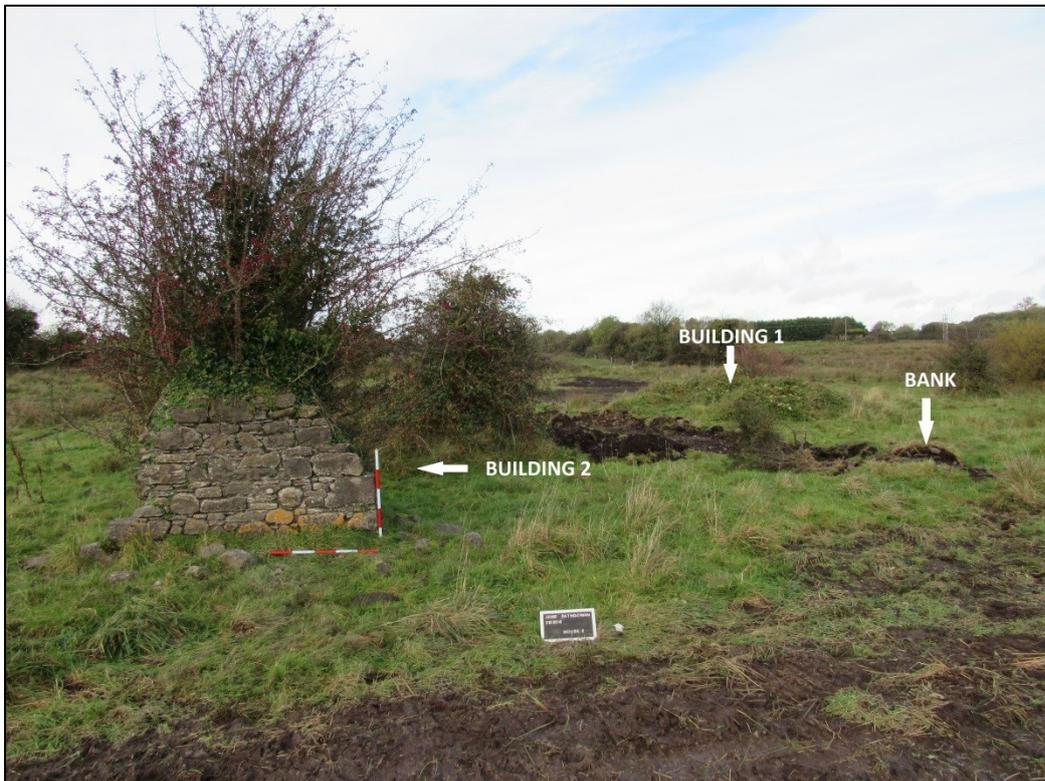
Plate 2: Archaeological Area 1, view of Building 2, Building 1 and bank, looking north (Scale: 1m x 2).

The two buildings C.1 and C.2 (AA1) accessed by an embanked avenue C.5 and C.6 and field boundaries C.15, C.17, and C.23 are depicted on the first-edition six-inch OS map (dated 1838) and on the 25-inch OS map (dated 1913). Parts of the stone walls are extant above ground level and are covered by vegetation; and it is very likely that entire foundations, and a metalled yard are preserved below the topsoil. Building C.1 correlates with the house marked (*a*) in plot 3 on the Griffith's Valuation map (published 1854) and Building 2 correlates with a perpendicular outbuilding. The farm was leased from *Smith* (no forename) to a tenant *Patrick Burn* and it comprised: *House, offices, and land*.¹⁹ The term *House* covered all buildings used permanently as dwellings; *office* was used to describe farm outbuildings such as a stable, turf shed, cow barn, corn shed, or piggery.²⁰ Nowadays, this farm lies within Sarsanstown townland, but in the nineteenth and early-twentieth century this was part of Rathgowan and Farranshock townland.

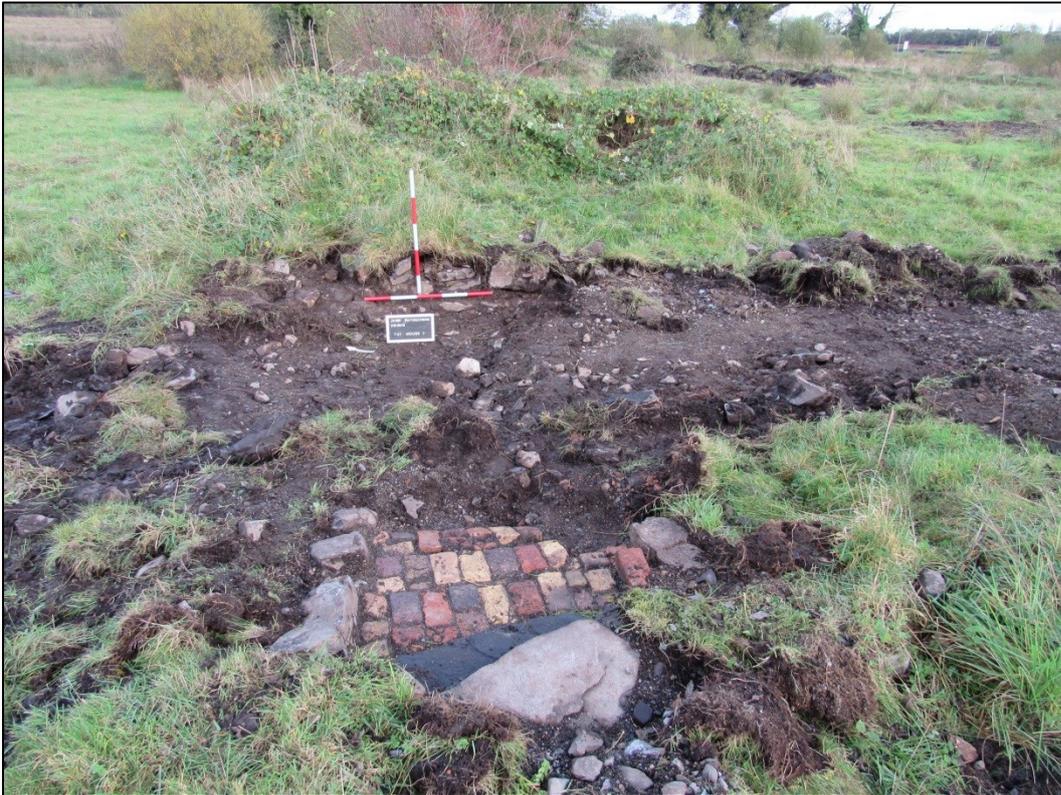
Plate 3: Archaeological Area 1, view of steps associated with Building 1, looking northeast (Scale: 1m x 2).

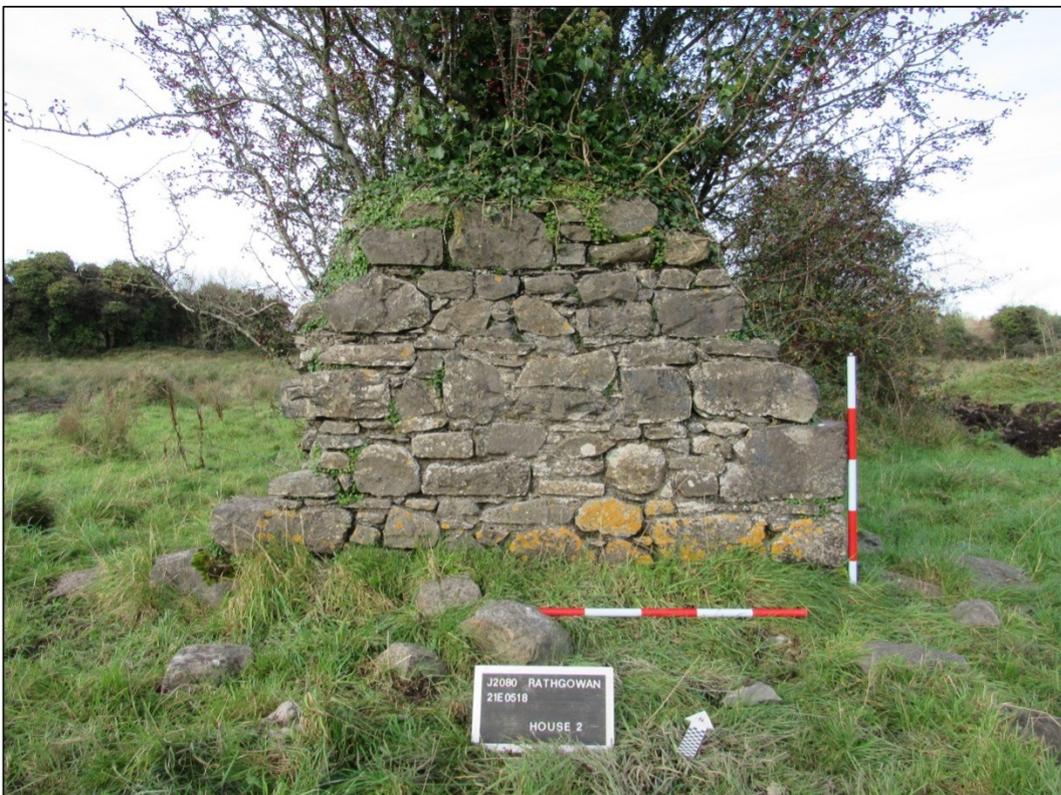
Plate 4: Archaeological Area 1, view of the southern gable wall of Building 2, looking north-northwest (Scale: 1m x 2).

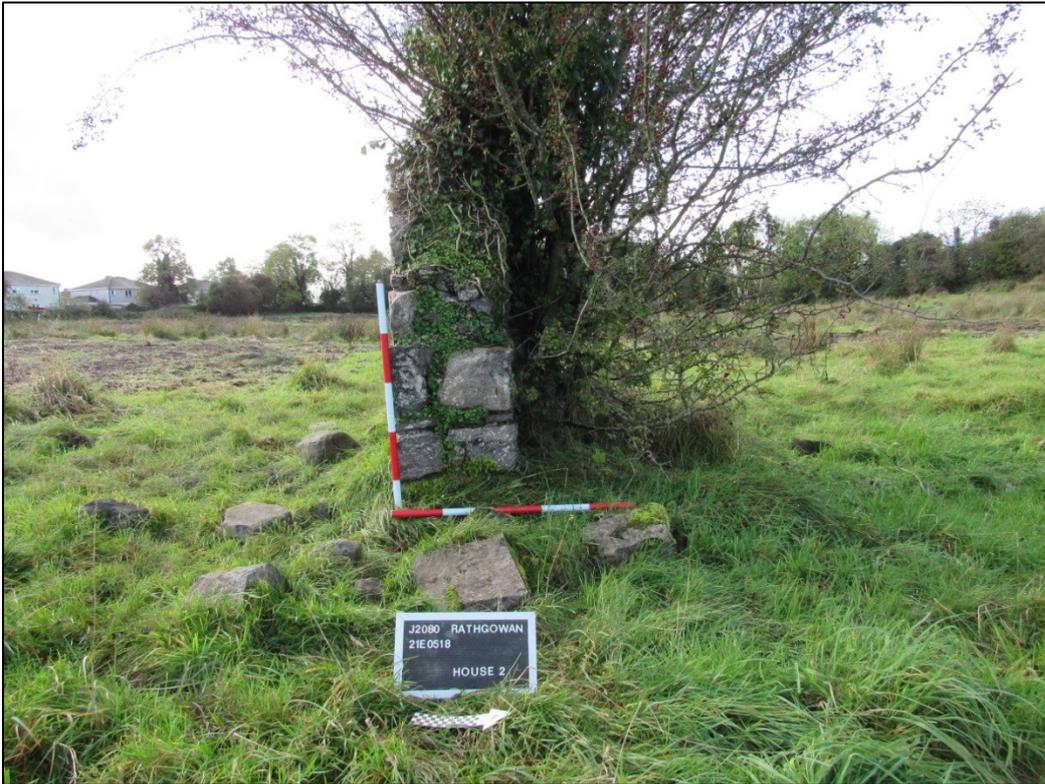
Plate 5: Archaeological Area 1, cross section of the southern gable wall of Building 2, looking southwest (Scale: 1m x 2).

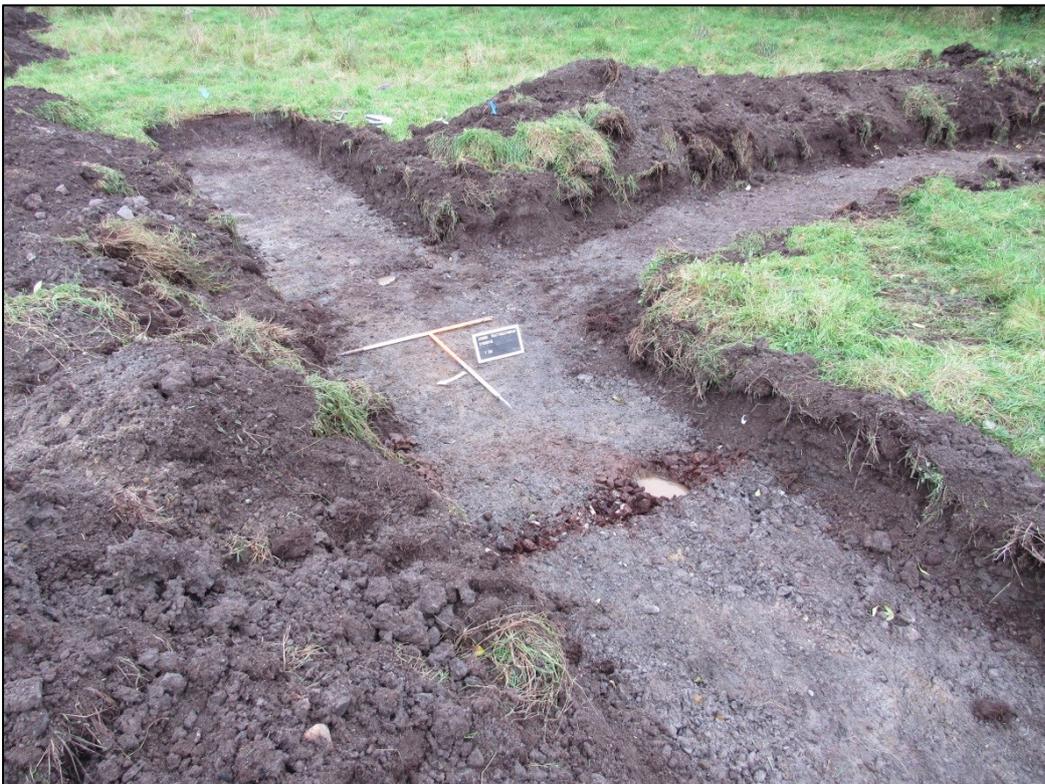
Plate 6: Area A, T35 and T38, view of field drains C.7 and C.8, looking southeast (Scale: 1m x 2).

Three field drains C.3 in T44, C.7 and C.8 in T34 were found throughout Area A. Drain C.3 was filled with peat and medium sized stones, while drains C.7 and C.8 were filled with small stones (Plate 6). Drain C.7 corresponds with response No. 2 recorded in the geophysical survey (Figure 8).

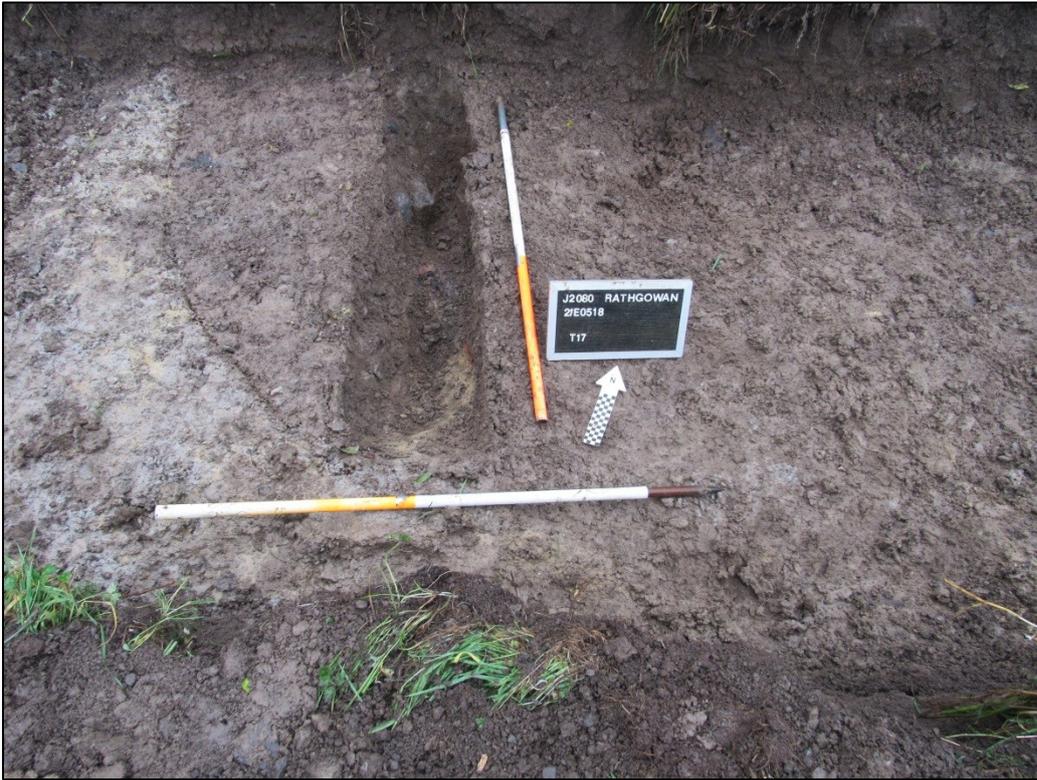
Plate 7: Archaeological Area 2, T17, view of pit C.13 with *in-situ* burning, looking west-northwest (Scale: 1m x 2).

An isolated pit C.13 of archaeological potential adjacent to a field drain C.12 was found in Trench 17 (Figure 9). Pit C.13 measured 2.7m by 1.4m by 0.2m in depth within the trench limit, and according to geophysical survey results it was subcircular in plan. The single fill of the pit comprised mid greyish brown clayey silt with moderate small to medium sub-angular and sub-rounded stones. A patch of charcoal-rich deposit that was sitting at the eastern side of pit C.13 overlaid red scorched natural subsoil, indicating *in-situ* burning (Plate 7 and Plate 8). Evidence of *in-situ* burning also occurred in the western terminus of a shallow ditch C.14, orientated east–west, and situated c.18.0m east of pit C13 (Plate 9 and Plate 10).

An isolated pit C.13 (AA2) with *in-situ* burning was identified in T17. It corresponds with a circular feature highlighted as a potential archaeological feature on the geophysical survey. A similar, potential archaeological feature is located c.5.0m to west of pit C.13. The date of pit C.13 is unknown as no artefacts were recovered.

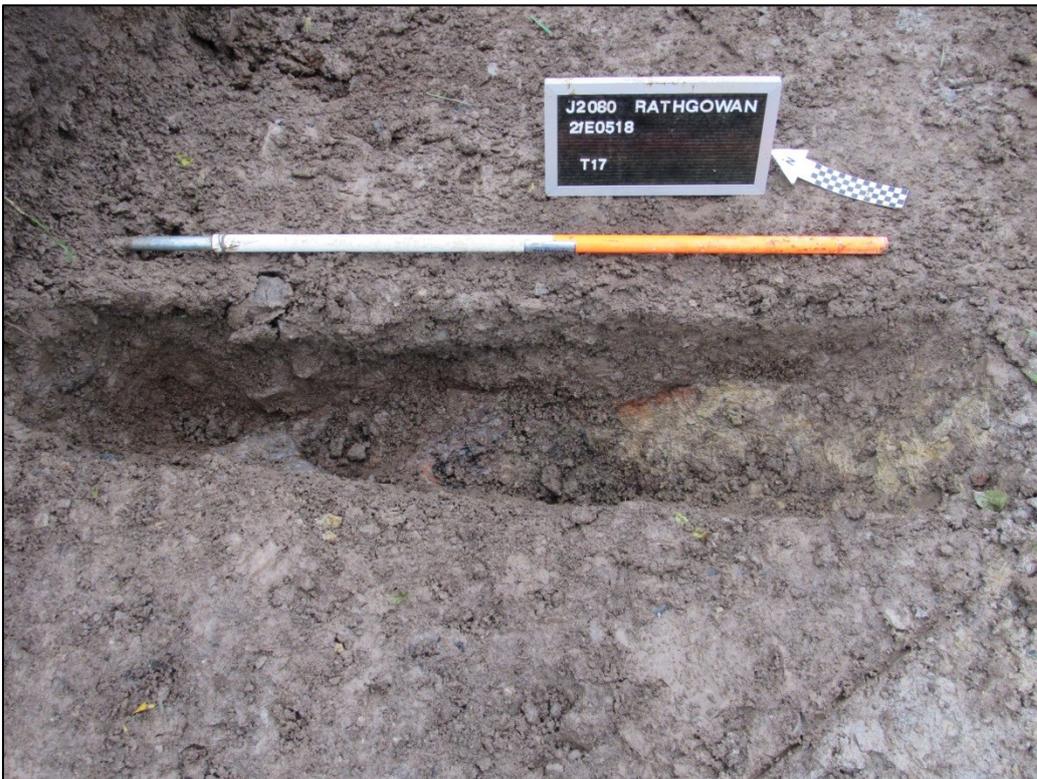
Plate 8: Archaeological Area 2, T17, view of pit C.13 with *in-situ* burning, looking east-northeast (Scale: 1m).

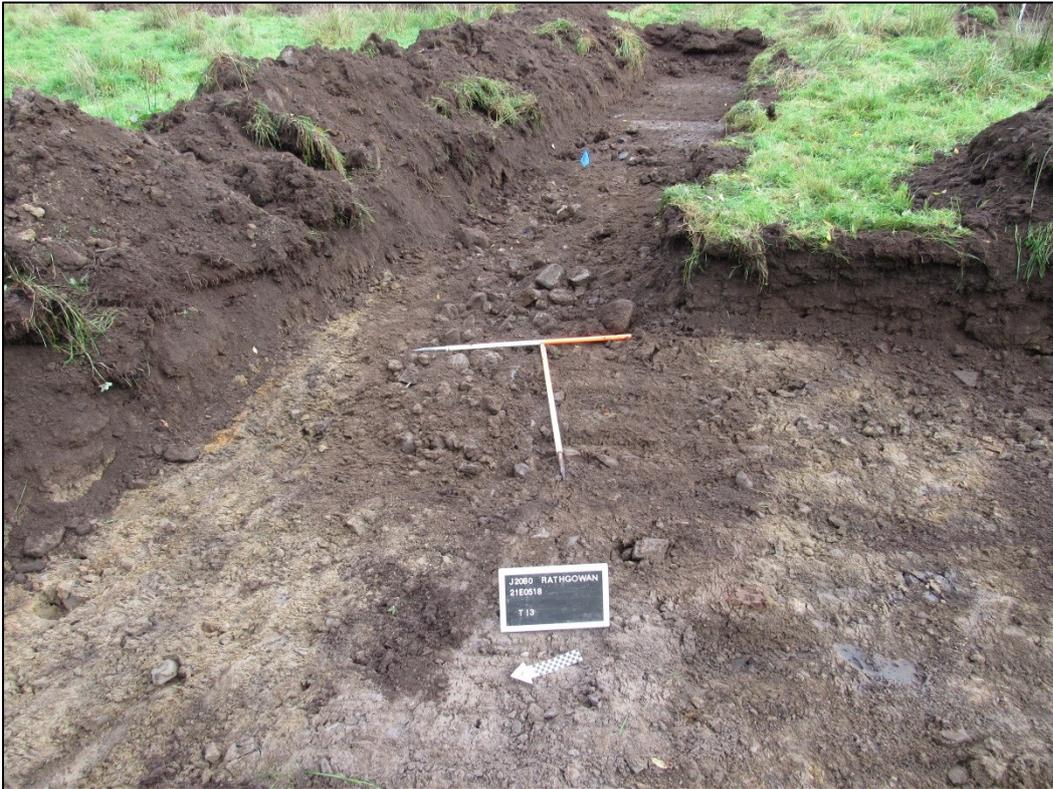
Plate 9: Area B, T13 and T13.1, view of ditch C.14, looking east-southeast (Scale: 1m x 2).

C.14	Ditch	T13, T13.1	Linear in plan. Western terminus in T13 and T13.1 Gradually sloping sides. Flat base. Single fill comprised mid greyish brown clayey silt with frequent small to large sub-angular and sub-rounded stones. Lens of charcoal measuring 0.2m in length by 0.14m in width by 0.1m in depth at the southern side overlying red scorched ground indicating <i>in-situ</i> burning.	7.0 (E-W) x 1.95 (N-S) x 0.18

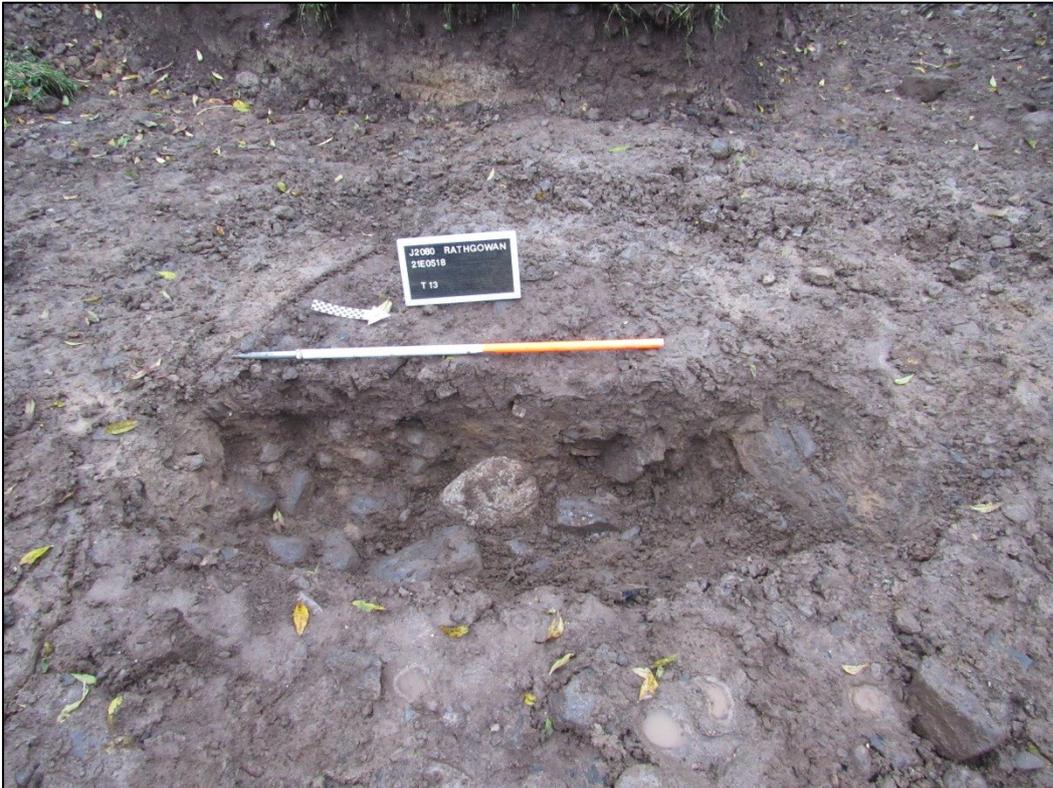
Plate 10: Area B, T13 and T13.1, view of terminus of ditch C.14, with *in-situ* burning, looking west-southwest (Scale: 1m).

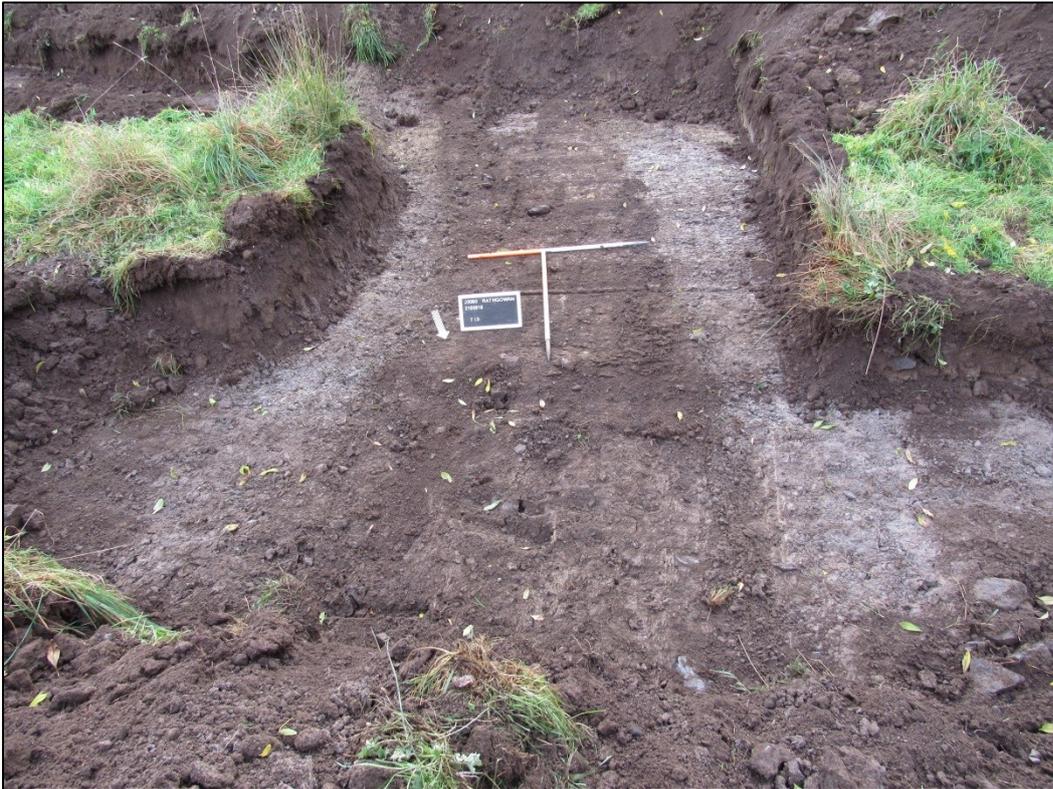
Plate 11: Area B, T13 and T14.1, view of field boundary ditch C.15, looking south-southwest (Scale: 1m x 2).

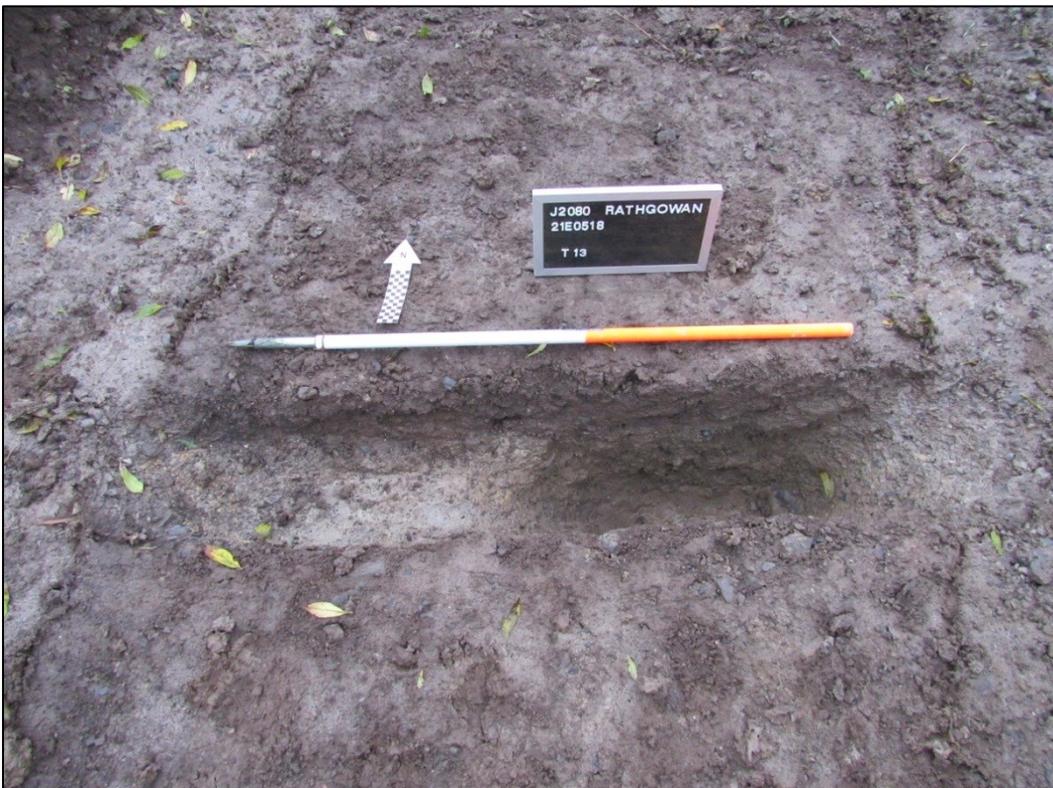
Plate 12: Area B, T13 and T14.1, view of field boundary ditch C.15, looking north (Scale: 1m).

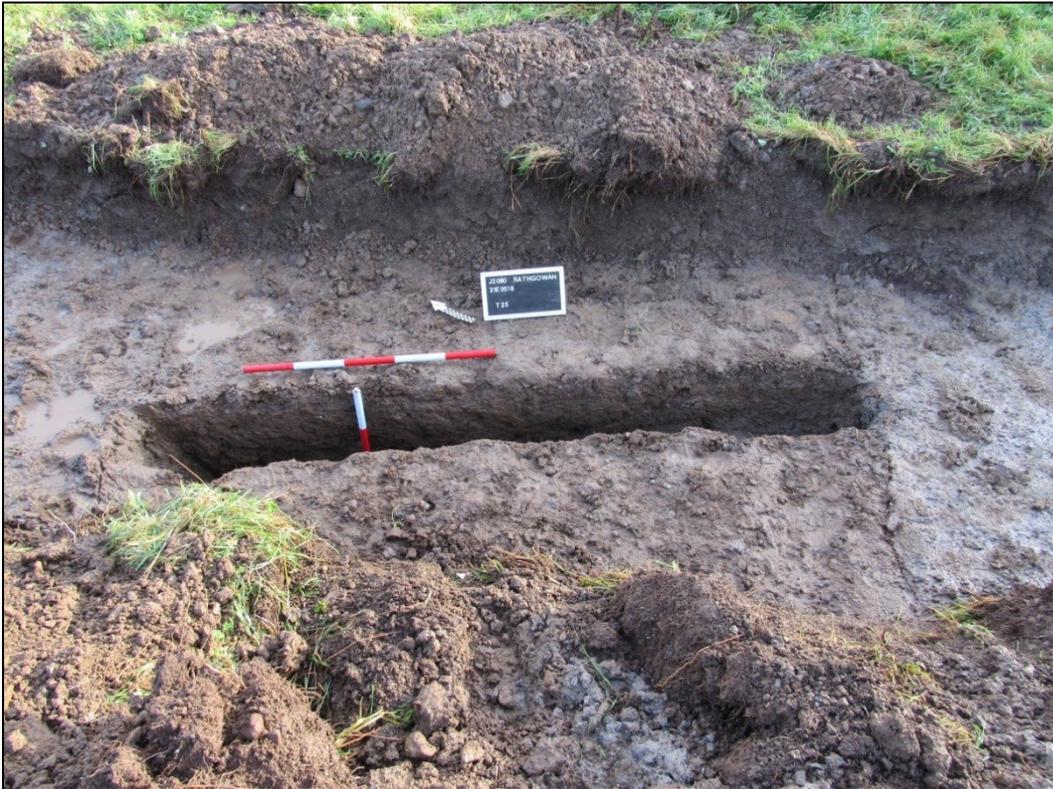
Plate 13: Area B, T25, view of ditch C.28, looking west-northwest (Scale: 1m x 2).

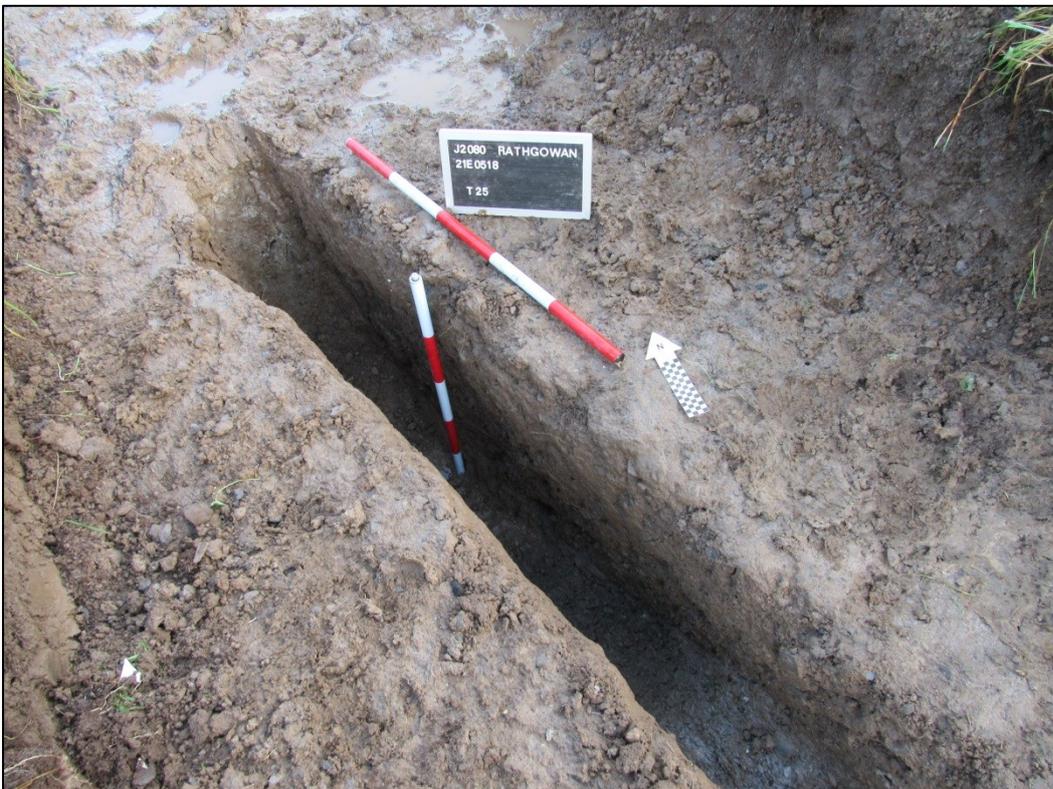
Plate 14: Area B, T25, view of ditch C.28, looking north-northwest (Scale: 1m x 2).

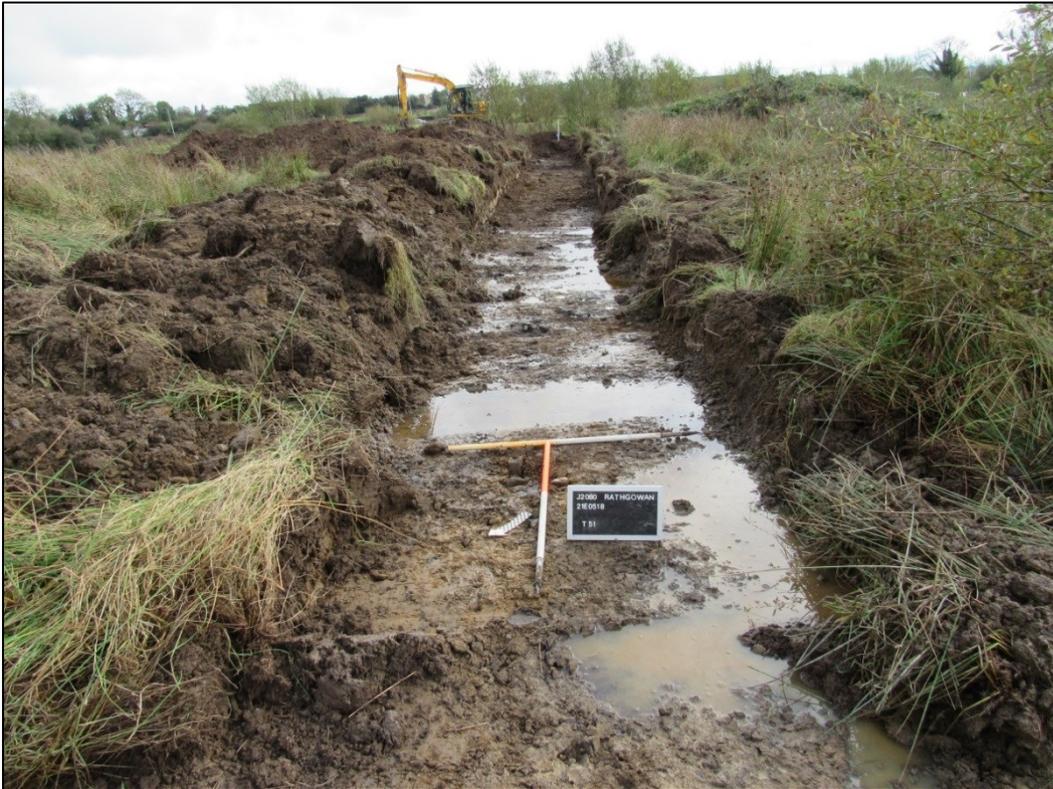
Plate 15: Area C, T51, overview of the natural subsoil, looking southeast (Scale: 1m x 2).

Area C was located in the northeastern portion of the development site, within Rathgowan or Farranshock townland, and was targeted by 20 test trenches T1–T10, T10.1, T51–T56 and T65–T66. Archaeological Area 3 (AA3) comprised a group of two adjacent charcoal-production kilns C.33 and C.35, and a possible posthole C.34, which were found in T51, T65 and T66 (Figure 7 and Figure 10; Plate 15–Plate 17).

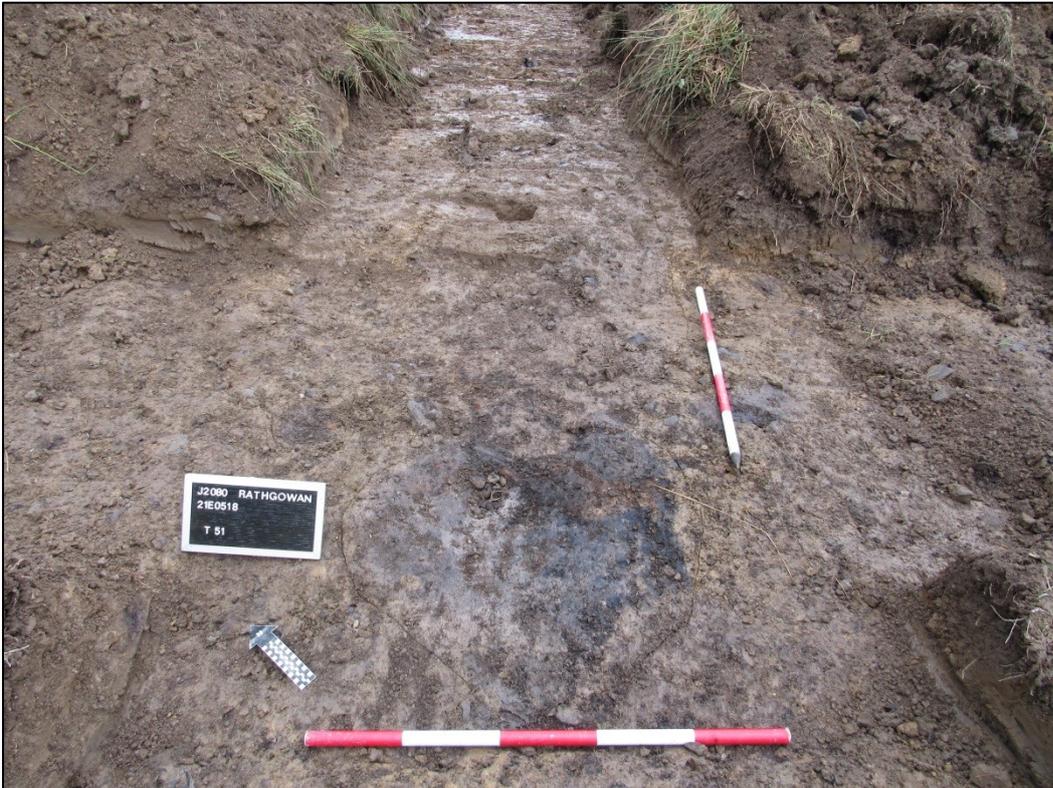
Plate 16: Archaeological Area 3, T51 and T65, view of charcoal-production kiln C. 33 and posthole C.34, looking northeast (Scale: 1m x 2).

Charcoal-production kiln C.33 was elongated in plan and measured 4.0m in length (northeast–southwest) by 1.1m in width (northwest–southeast) by min 0.09m in depth (Figure 10; Plate 16). The fill of this feature comprised mid greyish brown clayey silt. It was overlying a dark blackish grey charcoal-rich deposit consisting of moderate flecks of charcoal, and occasional small to medium sub-angular stones. There was a charcoal-rich deposit and red scorched natural subsoil at the western edge, indicating intensive *in-situ* burning, localised in the southwestern terminus of the feature. Possible stone lining was placed along the northeastern edge (Plate 16).

A group of two charcoal-production kilns C.33 and C.35, and a possible posthole C.34 (AA3), were found in T51. These kilns were elongated and sub-oval in plan respectively, and comprised charcoal-rich deposits. The date of charcoal-production kilns C.33 and C.35 is not known as no artefacts were recovered.

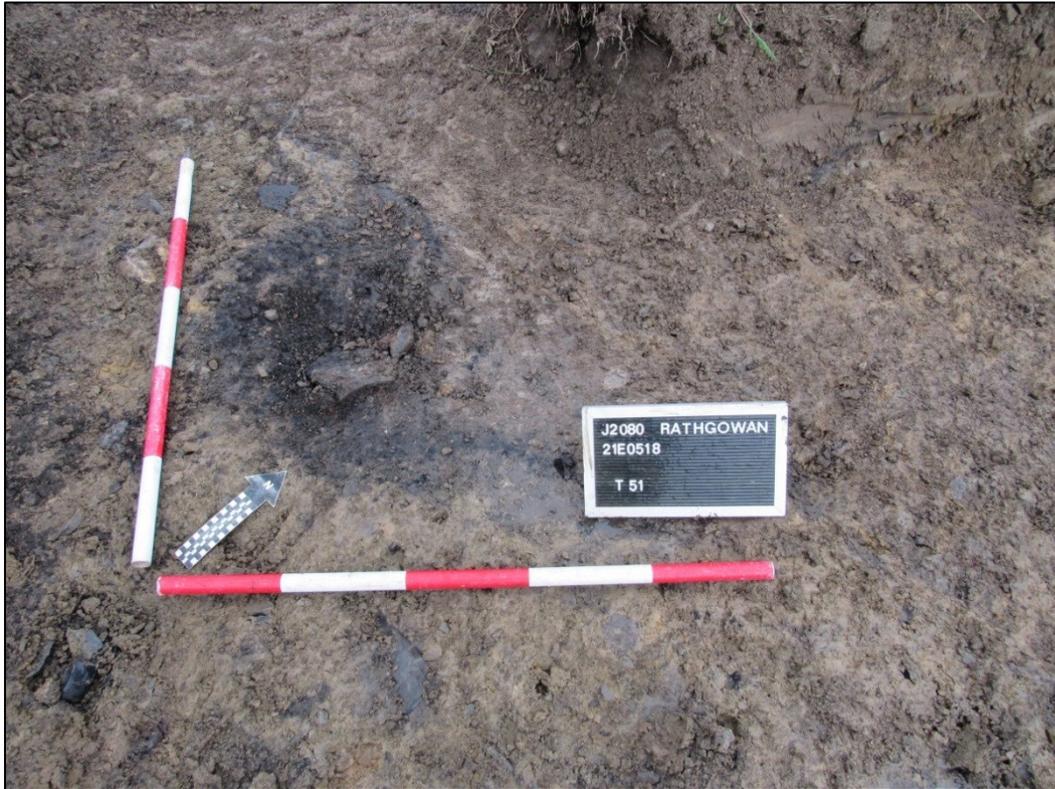
Plate 17: Archaeological Area 3, T51, view of charcoal-production kiln C.35, looking northwest (Scale: 1m x 2)

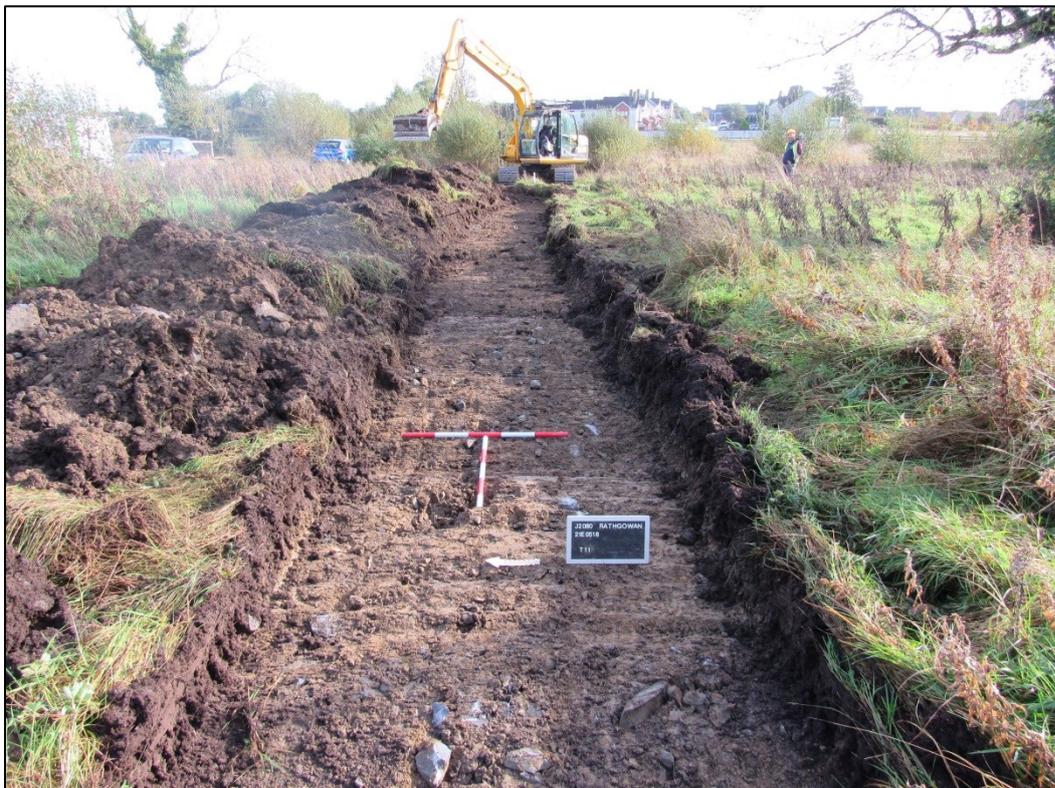
Plate 18: Area D, T11, overview of the natural subsoil, looking east (Scale: 1m x 2).

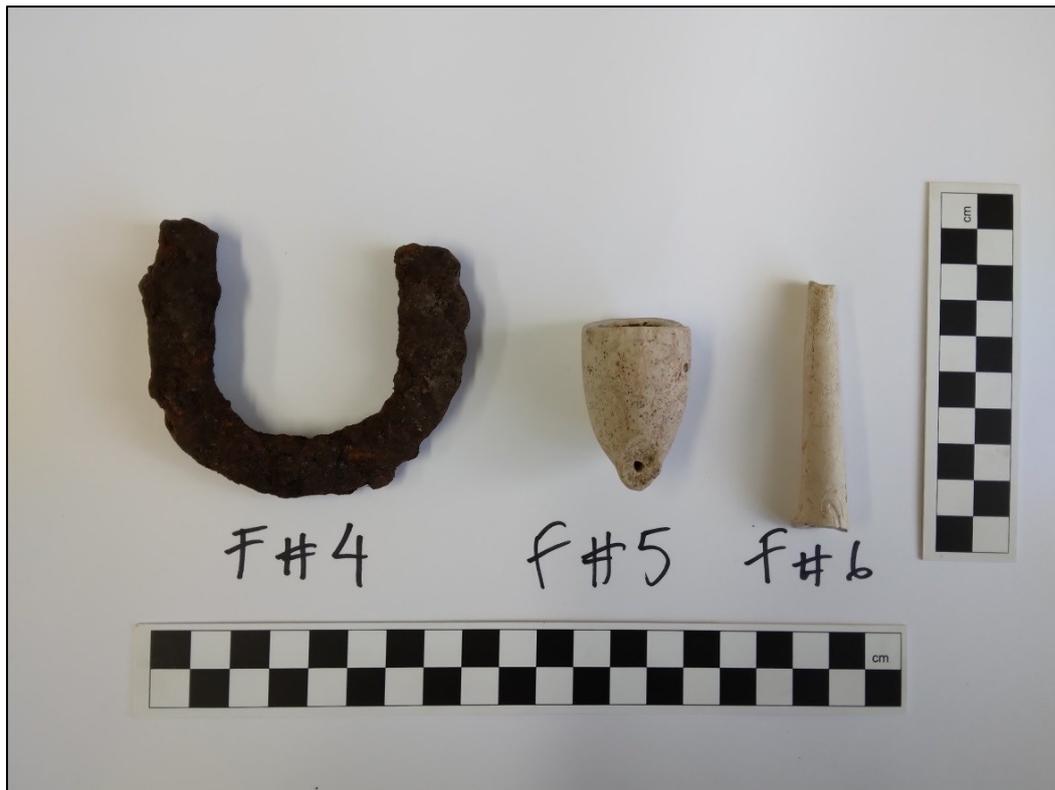
Plate 19: Topsoil finds: a heel pad in T40, clay pipes in T21 (Scale: 10cm, 20cm).

Associated with the buildings was an embanked avenue with a drainage ditch at each side depicted on the historical maps (Figure 4 and Figure 5). This avenue is still visible on the ground and ditches C.5 and C.6 were found in trenches T.34 and T37–40 (Appendix 1.1). In trench T40, a rectangular pit C.4 with an animal skeleton was discovered (Figure 8). It was located within the avenue, between two drainage ditches C.5 and C.6, and c.10m to southwest of Building 1; and most likely represents a farm animal that was discarded in the pit. A heel pad and a possible knife associated with the farm were recovered from topsoil in trench T40 (Plate 19).

Clay pipe fragments (bowl and stem) were recovered from the topsoil of T21. A modern porcelain sherd, with trademark stamp *BELLEEK*, was found on a spoil heap from T18 (Plate 19 and Plate 20).

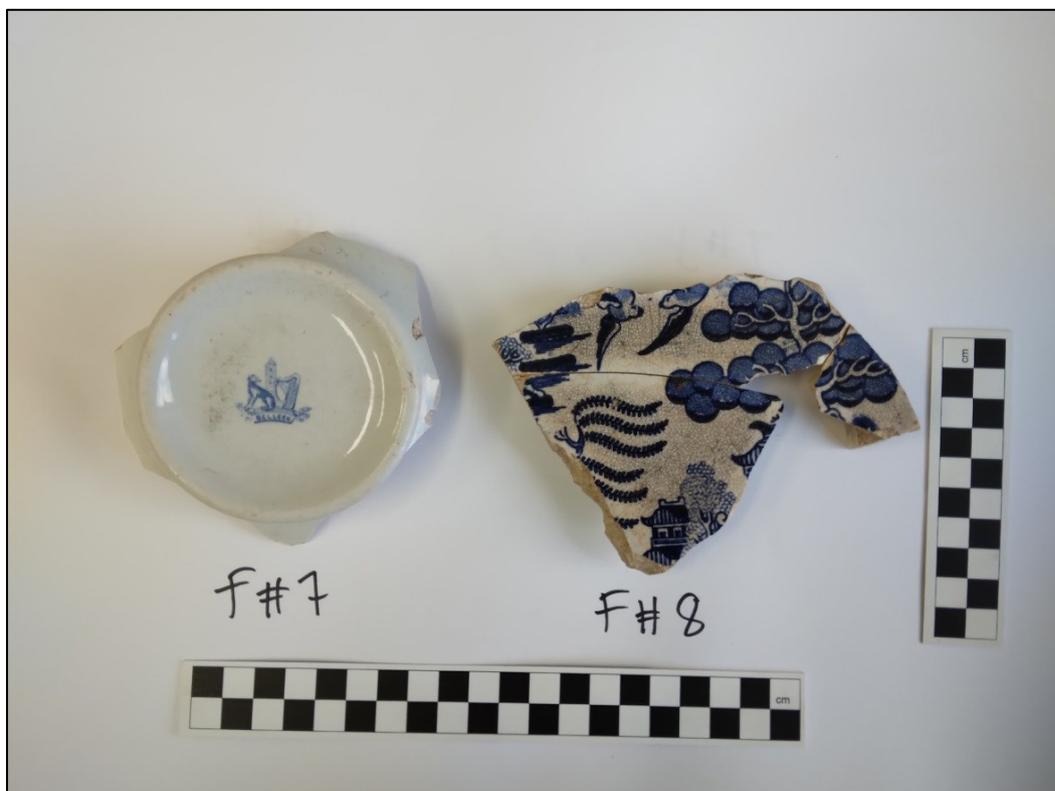
Plate 20: Topsoil finds: sherds of modern porcelain in T18 (left) and in T41 (Scale: 10cm, 20cm).

In the eastern edge of Trench 41, a portion of a stone wall was found, that along with other surviving walls possibly created a northeastern room (c.6.2m by 5.5m externally). This wall was orientated northwest–southeast and measured 1.4m in length by 0.45m in width by max. 0.3m in depth (Plate 3). The wall comprised of roughly hewn angular limestone blocks and stones (sample dimensions 45cm by 23cm; 32cm by 10cm), bound with a lime mortar mixed with small, rounded pebbles. The wall rested on a stone wall footing that measured min. 2.0m by 0.6m by min. 0.2m in height. In a hand-dug trench (Trench 41.1) 3.25m adjacent to the southeast of the wall, steps comprised of stones and bricks were found (Plate 3). The uncovered structure measured 1.4m northeast–southwest by 1.4m northwest–southeast externally, and 1.0m in width internally. The steps were built with red and yellow bricks (sample dimensions 20cm by 10cm by 6cm; 22cm by 12cm by 6cm), two slabs (sample dimensions 50cm by 30cm by 5cm), and were revetted on both sides by rough rectangular stones. In Trench 41 to the southeast of the building, remnants of a rough metalled yard were found, while to the northwest there was waterlogged peat. Three sherds of modern porcelain were recovered from topsoil in Trench 41 (Plate 20).
