**Title: Combined Stage 1&2 Road Safety Audit
For;
Rathgowan Housing Development, Co. Westmeath.**

Report reference: 1497R01

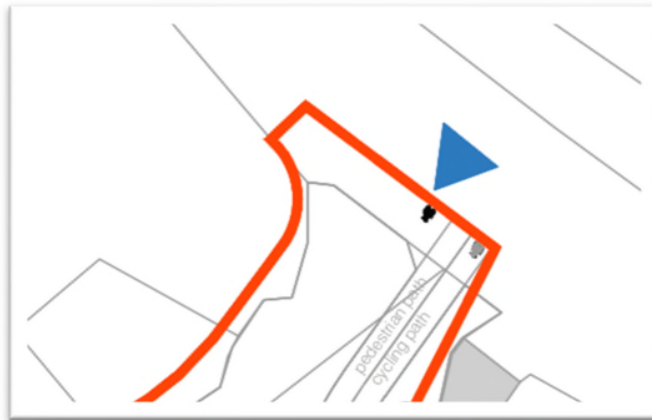
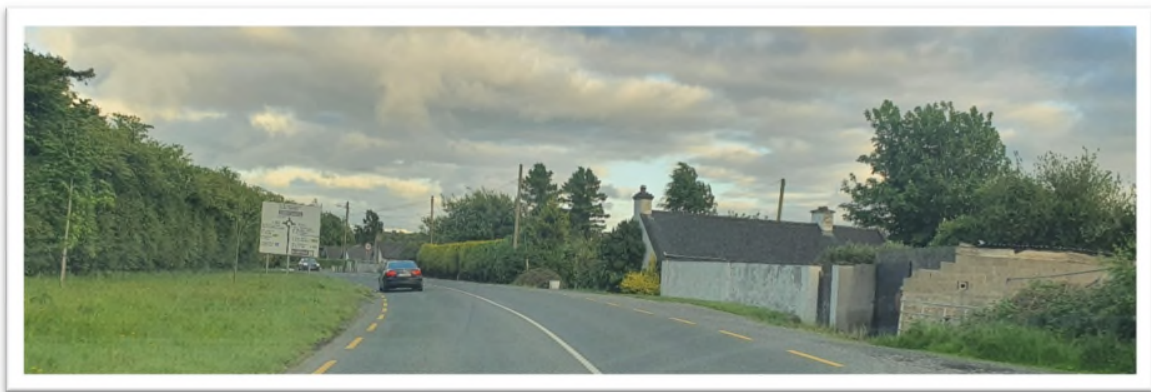
Drawing 202215-PUNCH-XX-XX-DR-C-0460 – C03, R393 pedestrian and cyclist connection.

The tie-in details of the footpath and cycle track at the R393 have not been provided. There are no existing dedicated pedestrian and cycling facilities and no crossing facilities. The new footpath and cycle track will lead to vulnerable road users crossing the carriageway where the speed limit is 60km/hr. If drivers do not expect to encounter crossing pedestrians and cyclists they may fail to slow resulting in collisions.

It is recommended that a crossing facility be provided with suitable dwell area, adequate lighting and with adequate warning for approaching drivers.

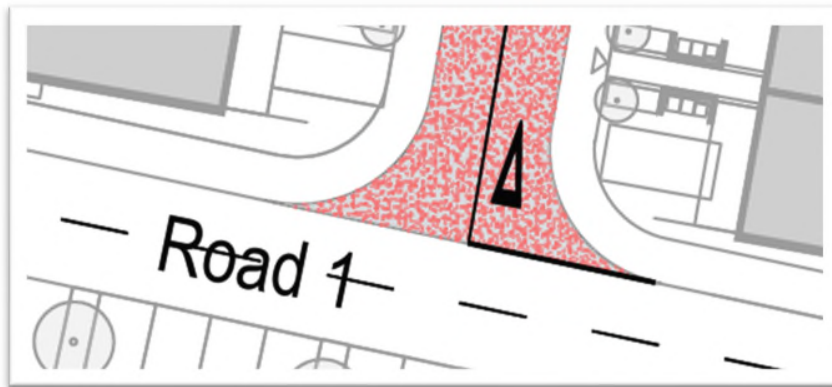
Drawing 202215-PUNCH-XX-XX-DR-C-0460 – C03, Corner radii.

Some of the corner radii at homezones and other local streets appear to have relatively large corner radii. This could lead to higher turning speeds, greater distances for pedestrians to have to cross and greater risk of cyclists being in the blind spot of turning vehicles.

Example only

It is recommended that corner radii be minimized in line with the guidance provided in DMURS.

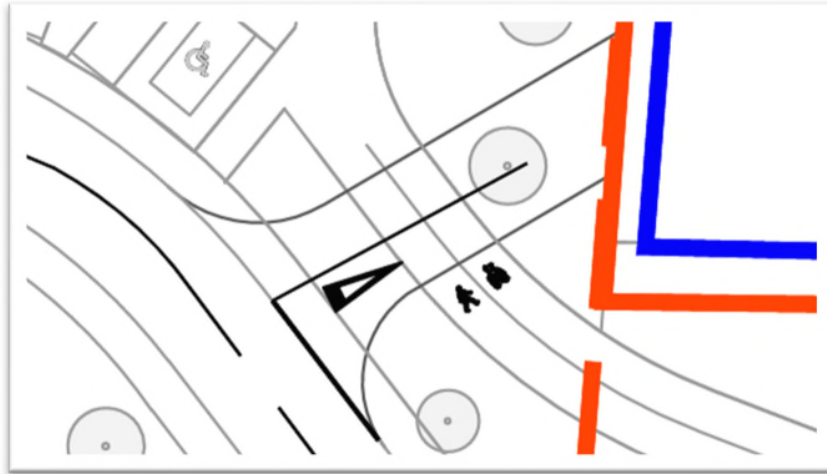
Drawing 202215-PUNCH-XX-XX-DR-C-0460 – C03, Spur road off Road 3.

There is a spur road off Road 3 which is presumed to be able to serve possible future development. It is unclear if the road or the cycle track and footpath which cross it will have priority. A lack of clear priority would lead to collisions.

It is recommended that the footpath and cyclist crossing be raised and provided in a different colour surfacing to the carriageway so that approaching drivers will know to beware of oncoming cyclists and pedestrians.

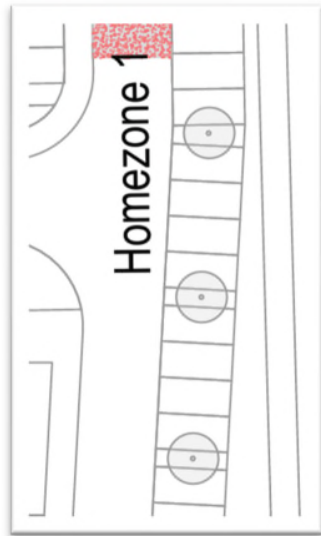
Drawing 202215-PUNCH-XX-XX-DR-C-0460 – C03, perpendicular parking spaces along Homezone 1 and other roads.

It is unclear if there is sufficient space for drivers to enter/egress from the perpendicular parking spaces on homezone 1 due to the narrow carriageway width. A lack of space could lead to material damage of other vehicles. There is also a lack of space for larger or emergency vehicles to turn at the ends of Homezone 1.

It is recommended that a swept path analysis be carried out to ensure that the parking manoeuvres can easily be carried in Homezone 1 and other similar dimensioned areas. Guidance on carriageway width/parking space width/buffer zones is provided in DMURS. Turning heads should be provided at the ends of the Homezone to avoid excessive lengths of reversing manoeuvres.

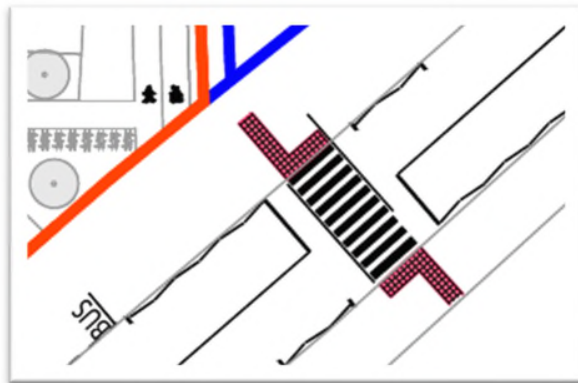
Drawing 202215-PUNCH-XX-XX-DR-C-0460 – C03, R494 toucan crossing

It is proposed to provide a toucan crossing on the R394. The cycle lanes on the R394 are however on-road. There are no facilities for cyclists to access the push buttons. This could lead to collisions with passing vehicles and waiting cyclists.

It is recommended that the on-road cycle lane be split onto a shared use area with suitable tactile paving at both sides of the toucan crossing.

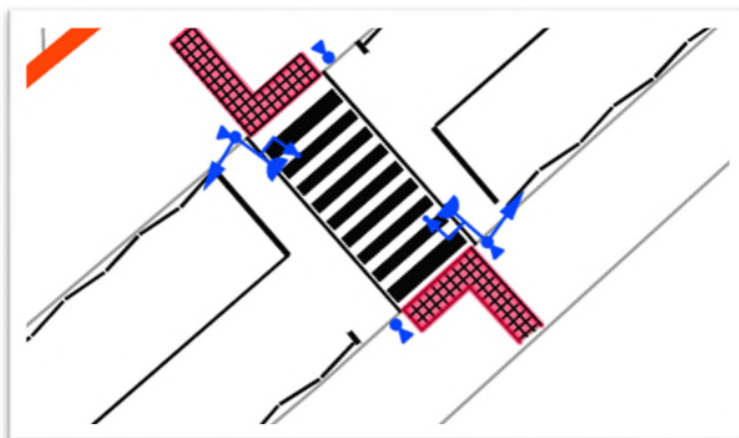
Drawing 202215-PUNCH-XX-XX-DR-C-0460 – C03, R494 toucan crossing.

It is proposed to provide only primary signal heads at the toucan crossing. A driver's visibility may be obscured to the single head by a high-sided vehicle or bus and this may lead to failure to stop when pedestrians or cyclists are crossing.

It is recommended that secondary signal heads be provided.

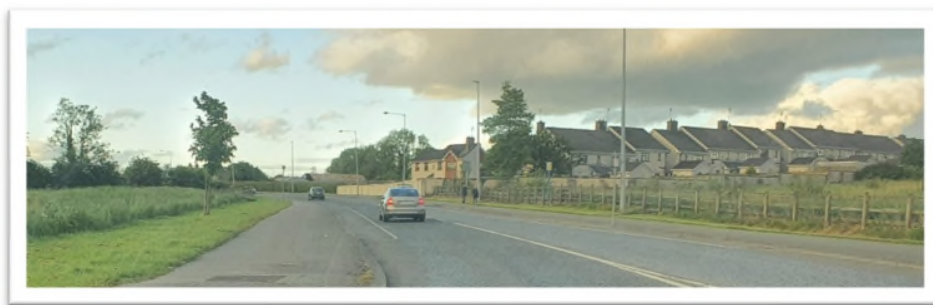
Drawing 202215-PUNCH-XX-XX-DR-C-0460 – C03, R394 toucan crossing.

It is unclear if crossing specific lighting is proposed at the toucan crossing on the R394. Without crossing specific lighting the lighting levels from the existing public lighting may not be sufficient for drivers to see pedestrians or cyclists with dark coloured clothes at night. This could lead to collisions.

It is recommended that crossing specific lighting be provided.

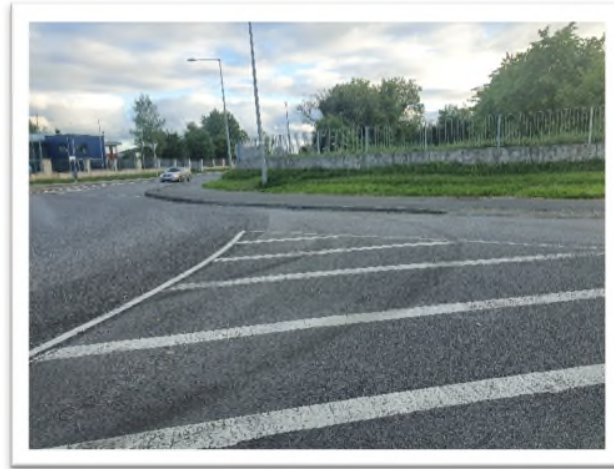
Drawing 202215-PUNCH-XX-XX-DR-C-0460 – C03, Farran Roundabout.

The existing Rathgowan Park Road arm of the Farran roundabout has a splitter island defined by road markings only. This arm of the roundabout will become much busier when the development is occupied and crossing pedestrians on the R394 will have fewer gaps in traffic and the likelihood of a collision will be increased. The hatched area will provide little refuge for those crossing pedestrians.

It is recommended that a solid splitter island be provided to give refuge for crossing pedestrians. The island should have dropped kerbs and tactile paving as appropriate.
